## **Investigation into the *in situ* thermal performance of 2 static caravans - Assessing the change in heat loss behaviour due to thermally superior replacement windows.**

**Client:** Camden Group  
Steeple Road Industrial Estate  
Antrim  
Northern Ireland  
BT41 1AB

**Site Address:** Units C05 & C10, Holly Bank  
Blue Dolphin Holiday Park  
Filey  
North Yorkshire  
YO14 9PU

April, 2015

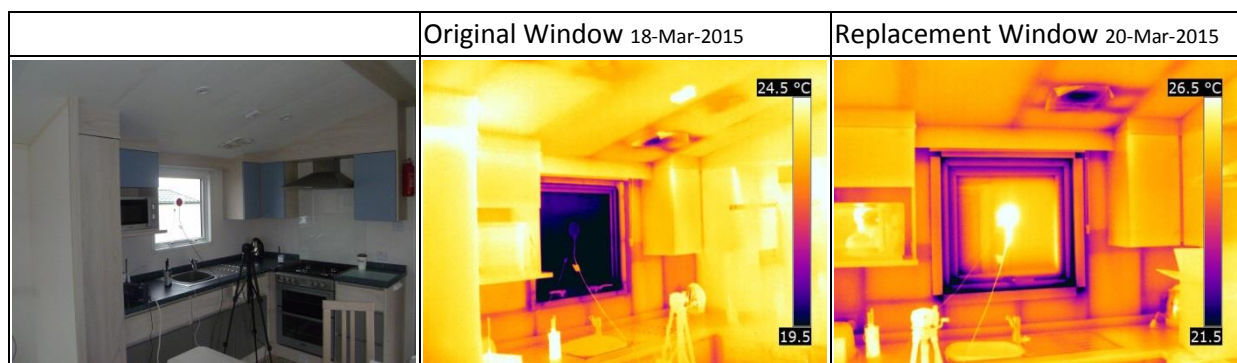
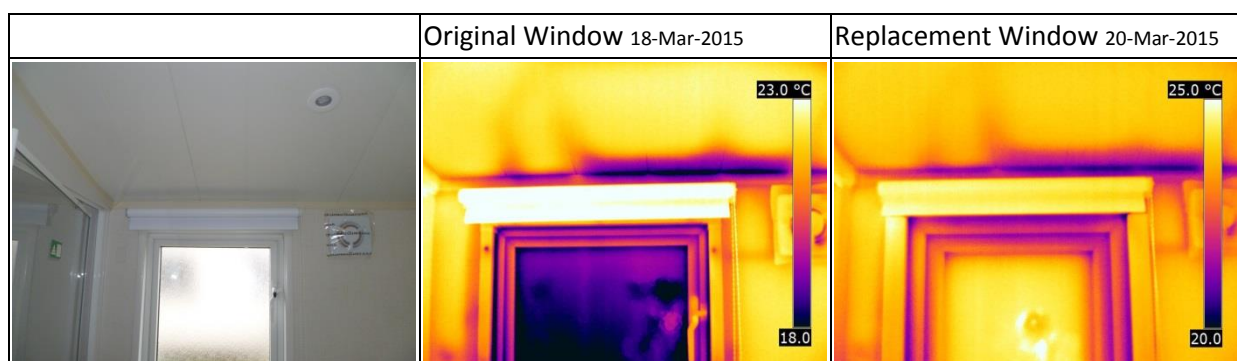
Figure 1: C05 Kitchen window – original and replacement

Figure 1 & Figure 2 show the original and replacement windows in C05. In both examples the thermal images were captured on arrival at the site (on the 18<sup>th</sup> and 20<sup>th</sup> March respectfully) prior to any other access being gained to the caravan that morning. Additionally, both sets of thermal images were set to a temperature span of 5 °C to allow better direct comparisons to be made between them. The difference in surface temperature, and hence heat loss, due to the replacement glazing is stark; the surface temperatures of the original glazing were the lowest observable temperatures in the images, indicating the maximum heat loss and the first or most likely areas to foster surface condensation.

What is also noticeable in Figure 1 & Figure 2 is the surface temperature of the opaque elements and window frames. The window frames on the original windows are consistently cooler than the structural timber within the walls and ceiling. In contrast, the replacement frames display frame surface temperatures much closer to that of the areas of the plane elements with timber beneath.

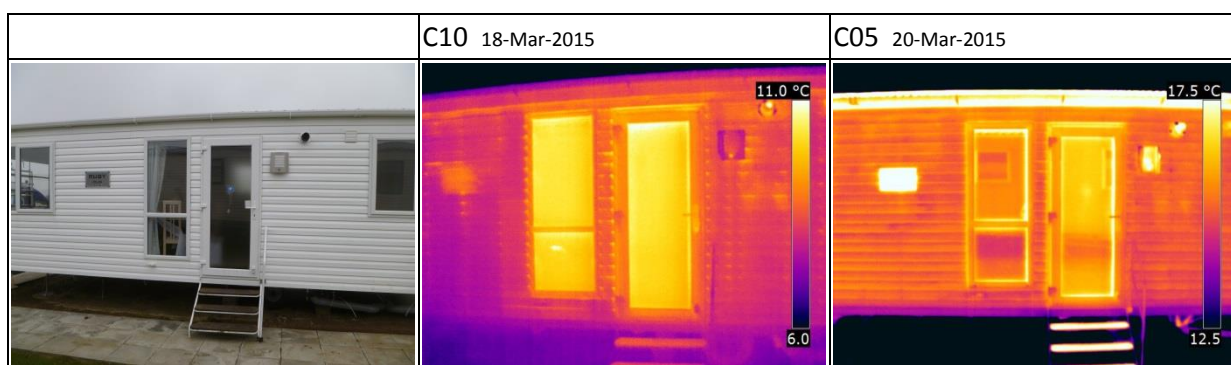
Figure 3: Doors and adjacent window showing difference in external surface temperature

The difference between the original window performance and the replacement glazing can be seen most clearly on caravan C05, where the window adjacent to the door was replaced prior to the door being upgraded. Figure 3 displays some difference between the 2 types of glazing when viewed from the outside, although variations in atmospheric conditions and reflection prevent any accurate analysis.

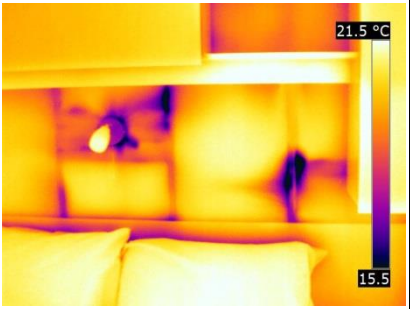
<p>16-Mar-2015</p> <p>C10 – Bathroom</p> <p>Air leakage from the boxed-in services for the toilet was detected.</p>

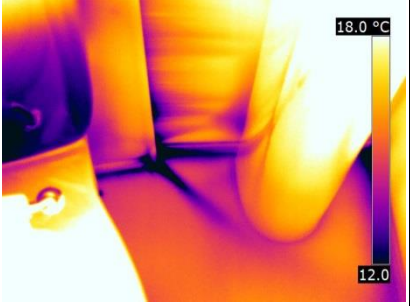
<p>16-Mar-2015</p> <p>C05 – Kitchen</p> <p>Infiltration around the kitchen window was detected.</p>	   	   
<p>16-Mar-2015</p> <p>C05 – Kitchen</p> <p>Air leakage was detected around the sealed extract fan and around the window.</p>

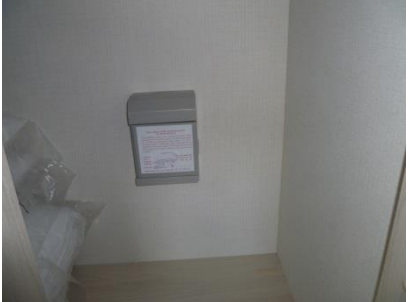
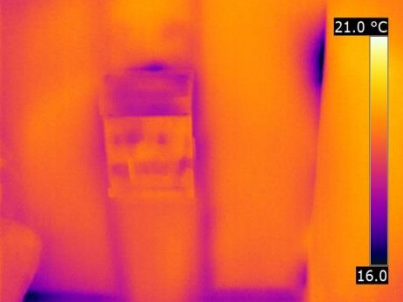
<p>20-Mar-2015 C05 – Main Bedroom</p> <p>Air leakage around the consumer unit emerged at warmer temperatures than directly infiltrating air due to a longer air leakage path.</p>

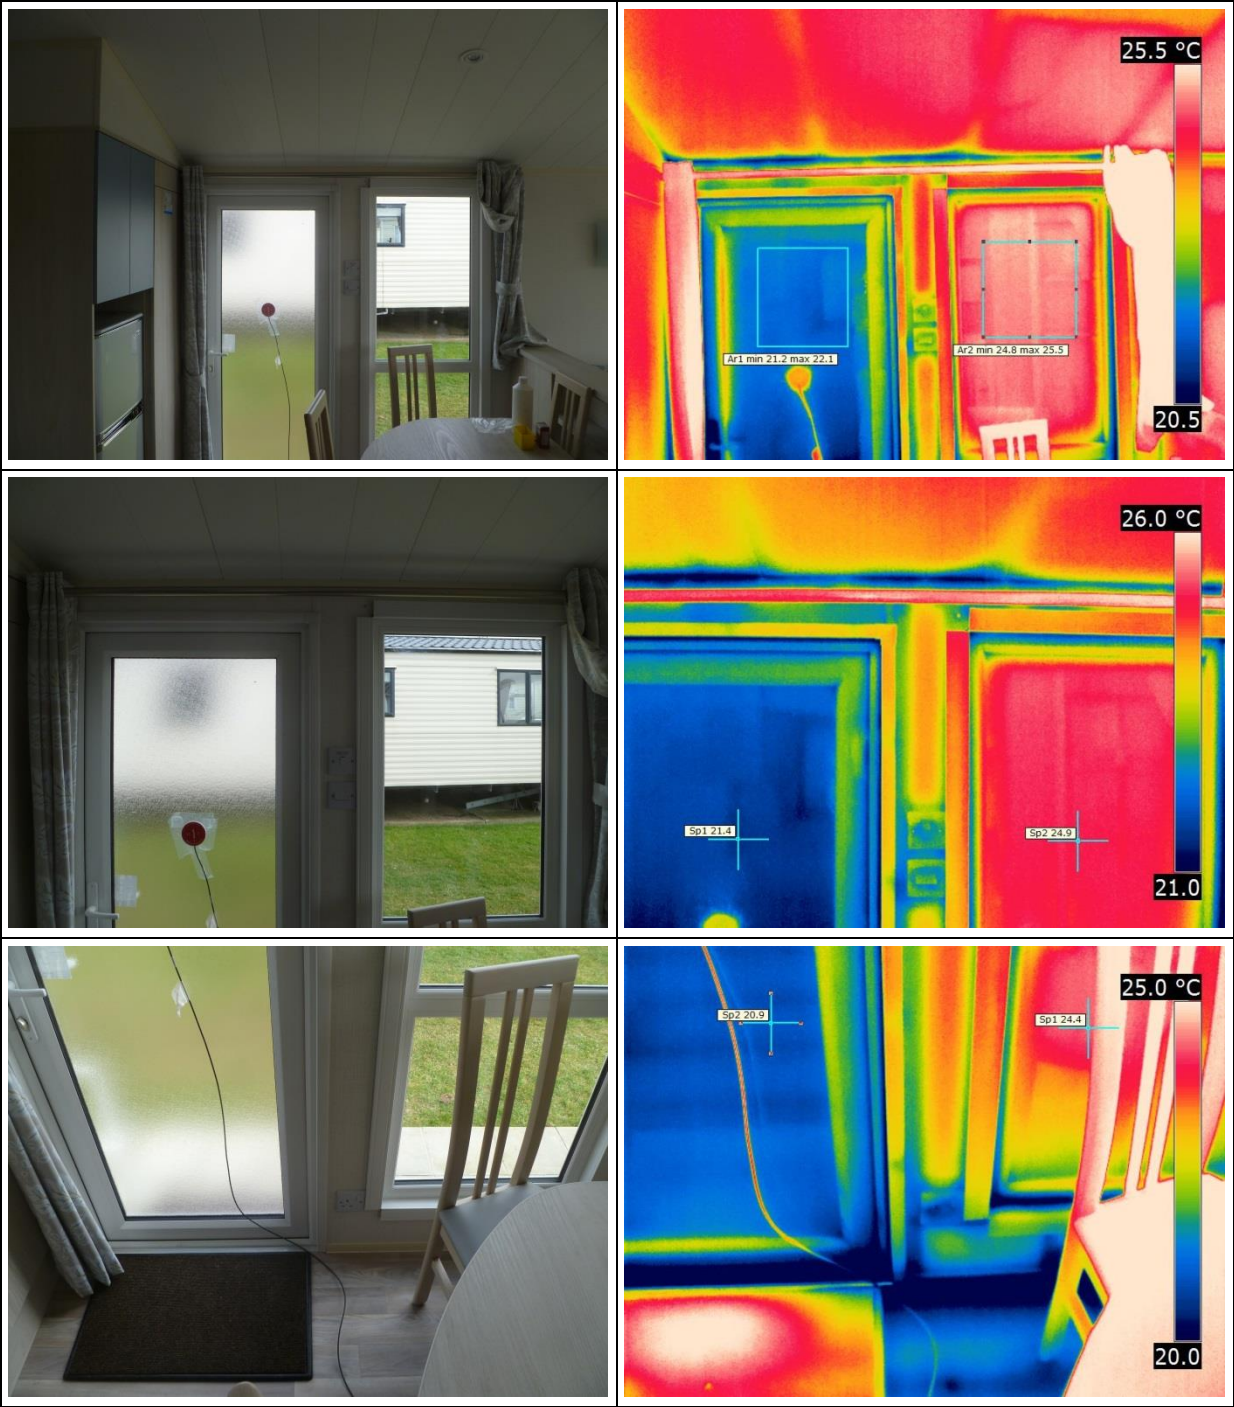
Direct comparison of the original door and a replacement window in C05:
